PERATION

GREENHOUSE

SCIENTIFIC DIRECTOR'S REPORT

ANNEX 3.2 U. S. NAVY STRUCTURES

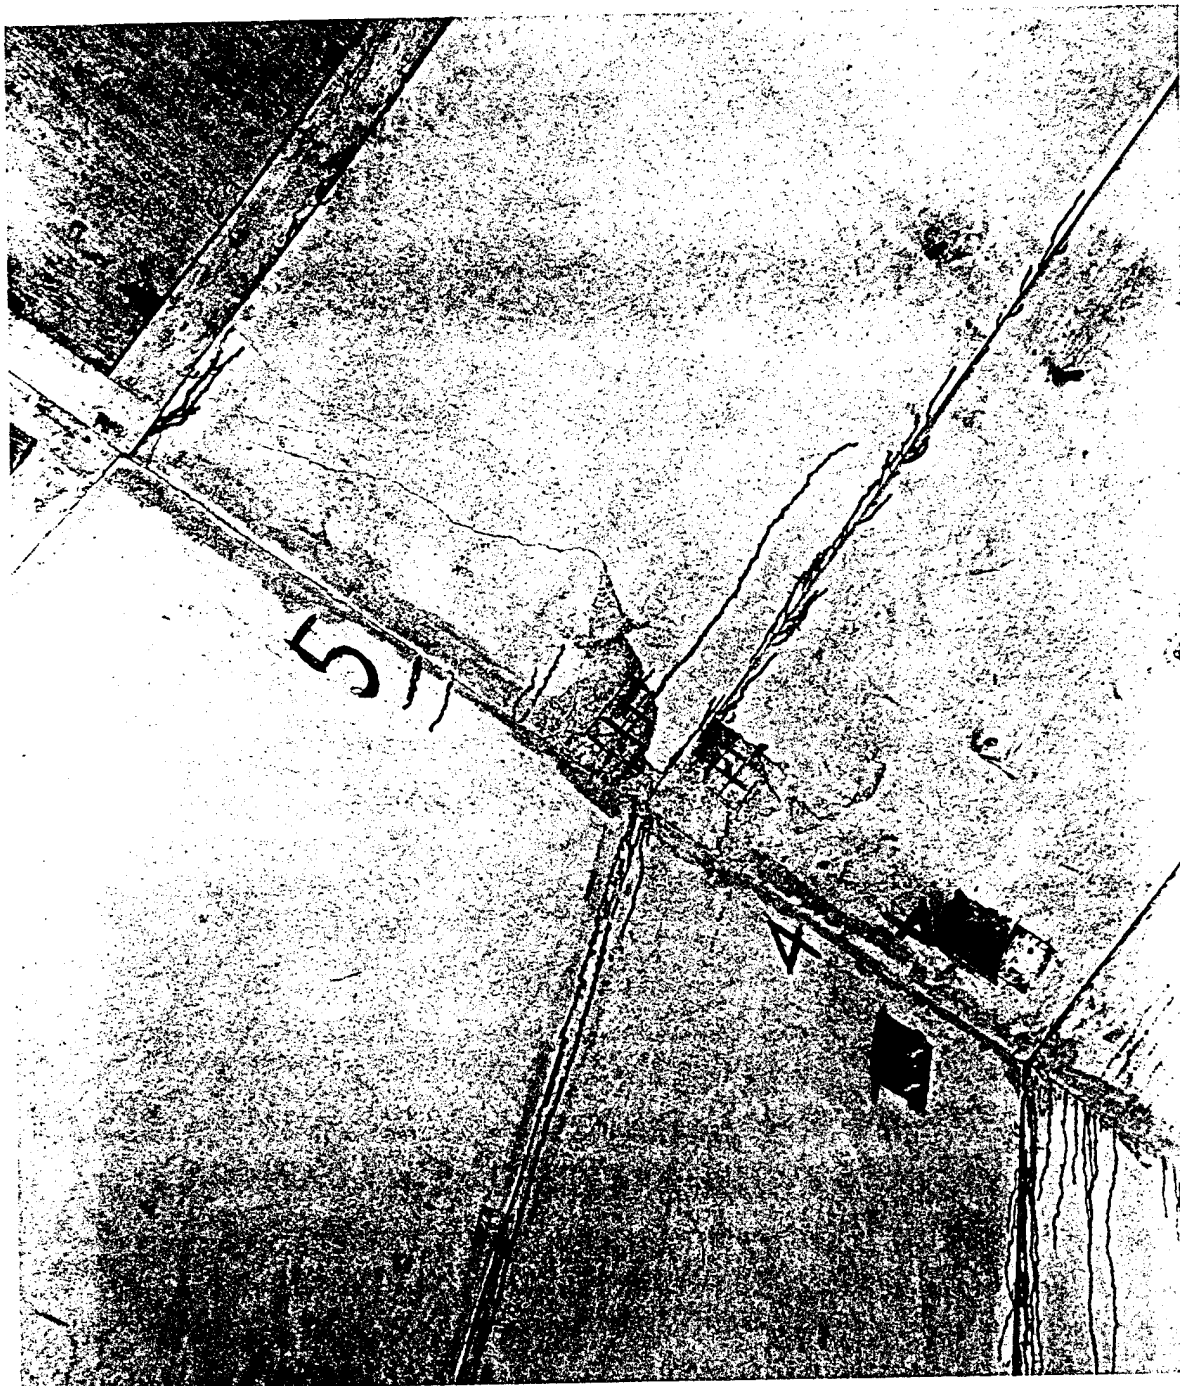
Fig. L. 393 Interior Detail of Failure of Roof Section of Ribs-out Panels Fourth and Fifth from Right End of Structure,
3.2.4b

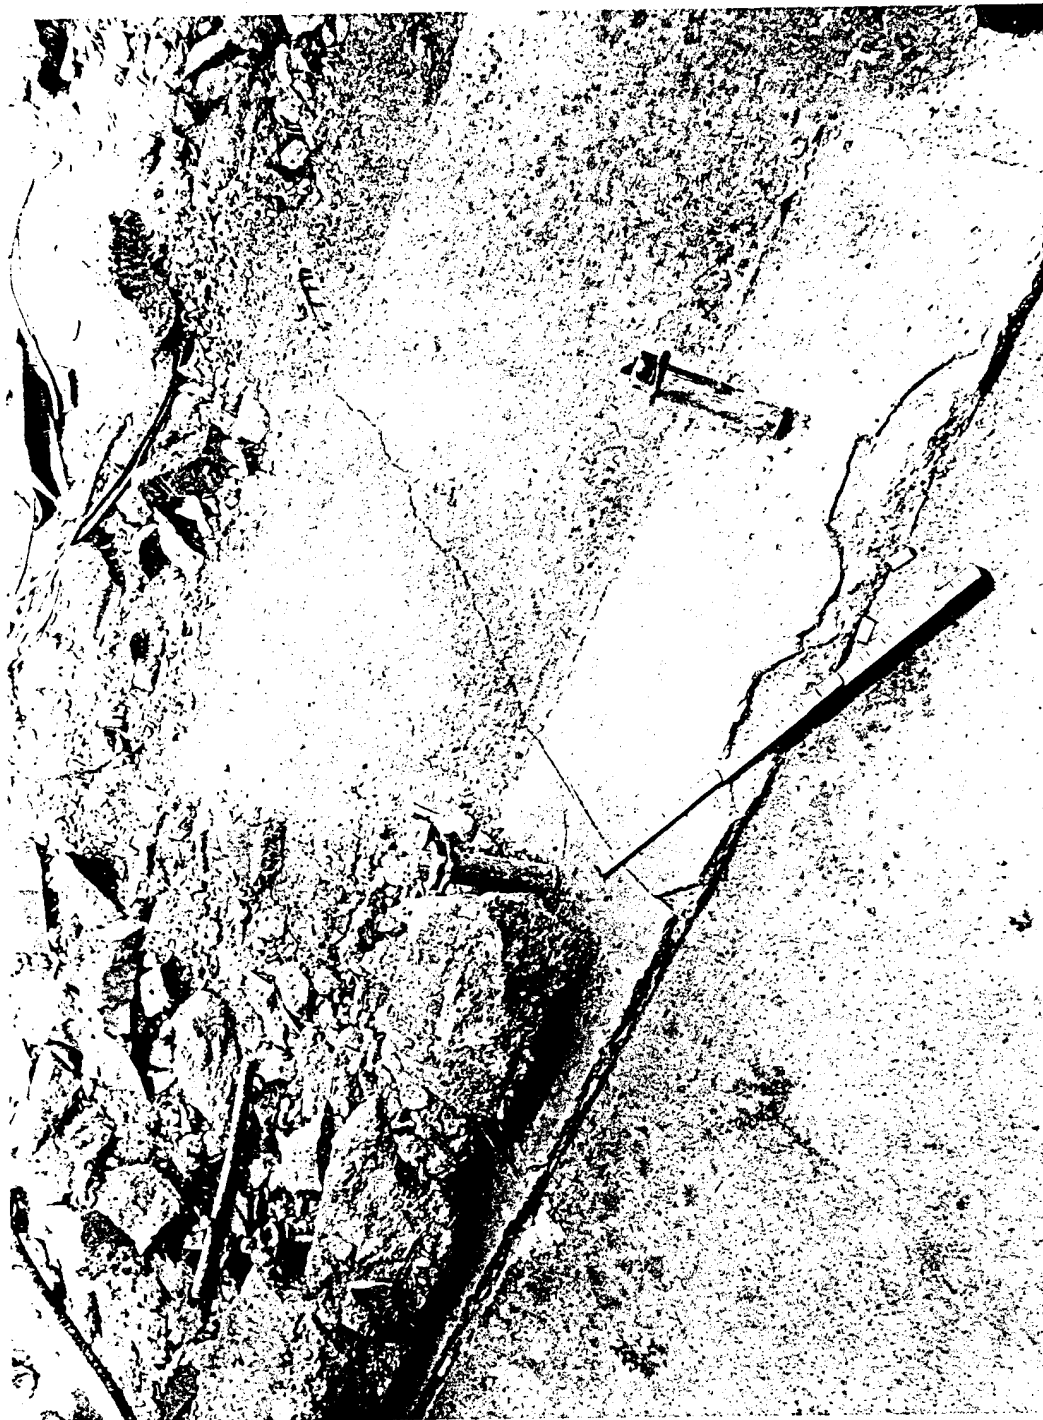
Fig. L. 395 Detail of Right End Foundation Crack at Rear Third Point, Structure 3. 2. 4b

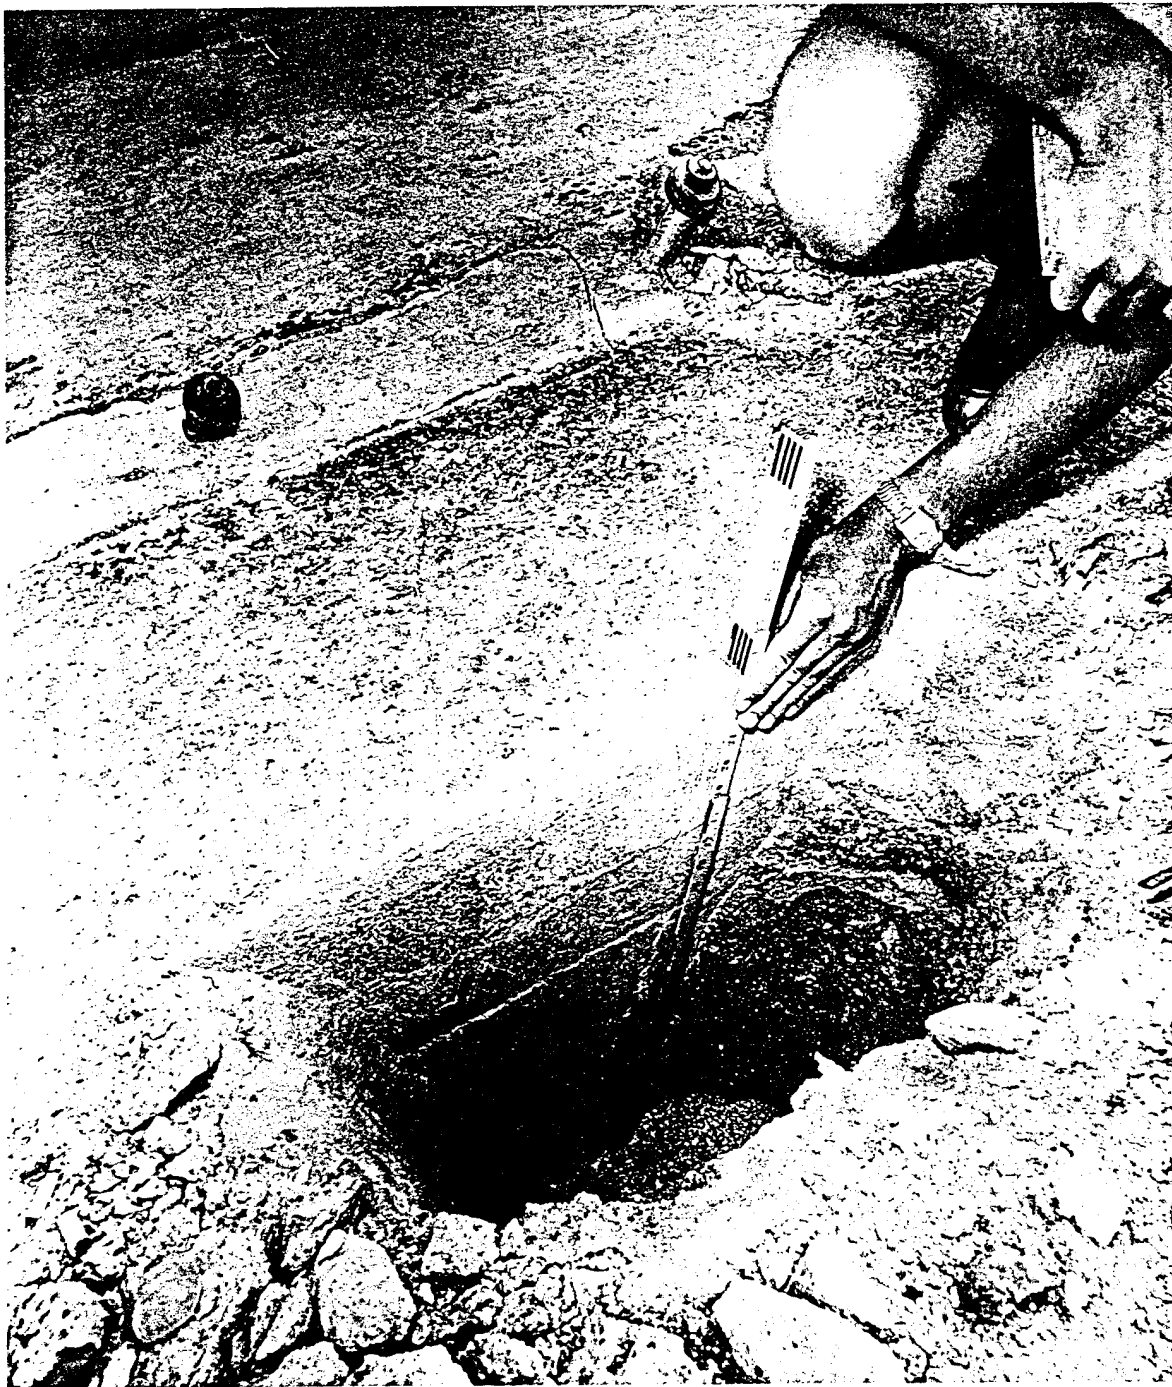
Fig. L. 396 Detail of Right End Foundation Crack Showing Crack Width Diminishing with Depth, Structure 3.2.4b

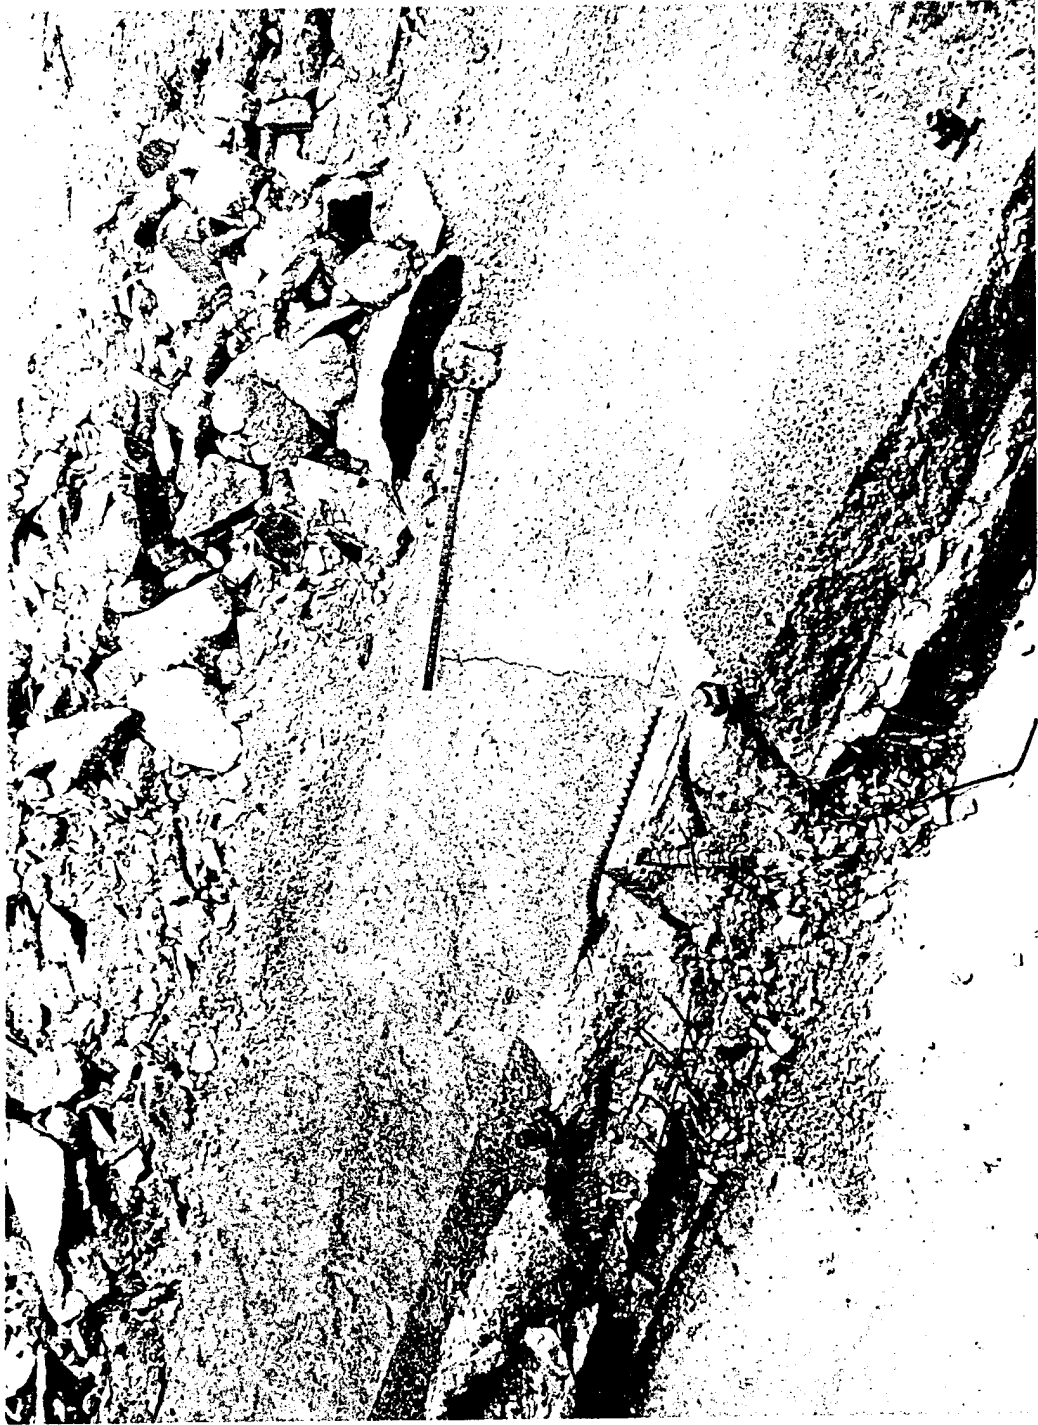
Fig. L.397 Detail of Left End Foundation Crack at Rear Third Point, Structure 3.2.4b

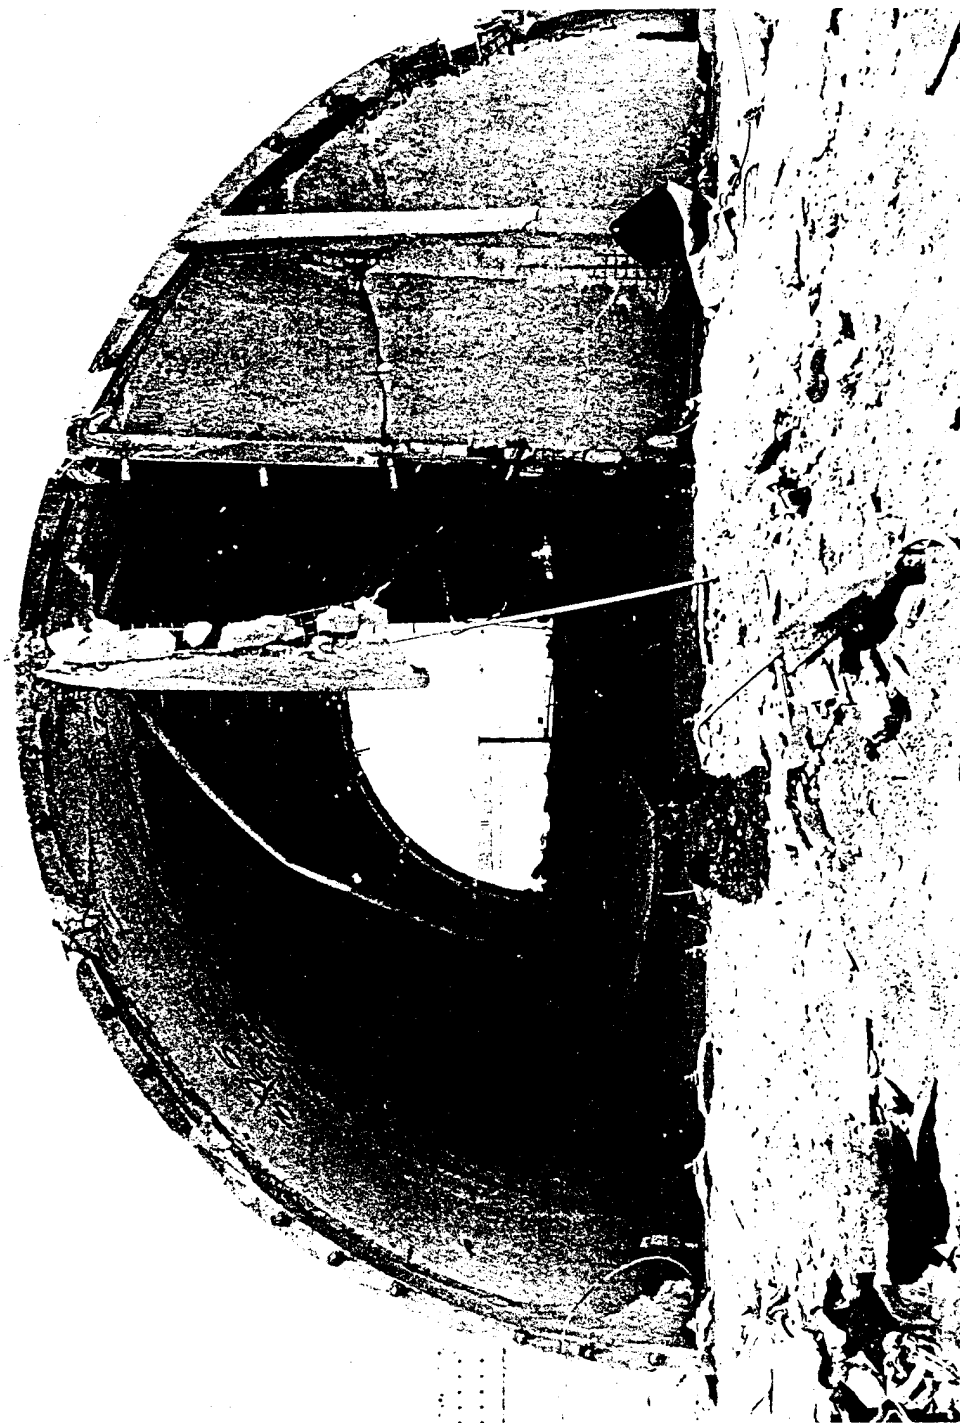
Fig. L. 403 Close-up of Left Side, Structure 3.2.5. Note top half of center panel hanging by a single bar.

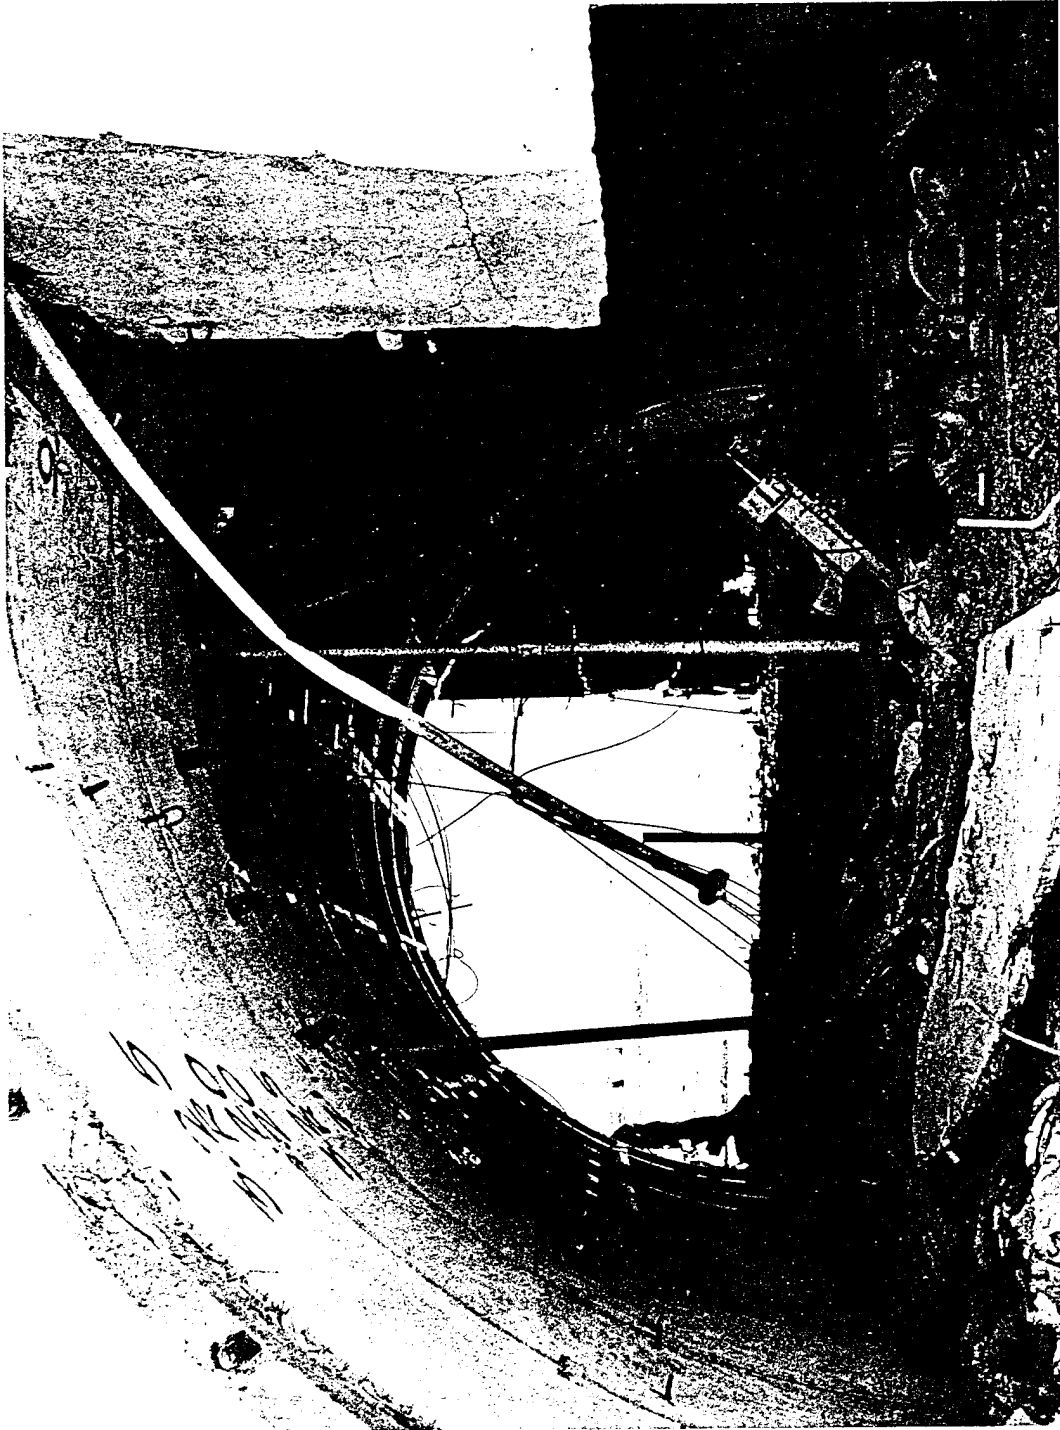
Fig. L. 404 End-wall Panel Debris from Left End, Structure 3.2.5

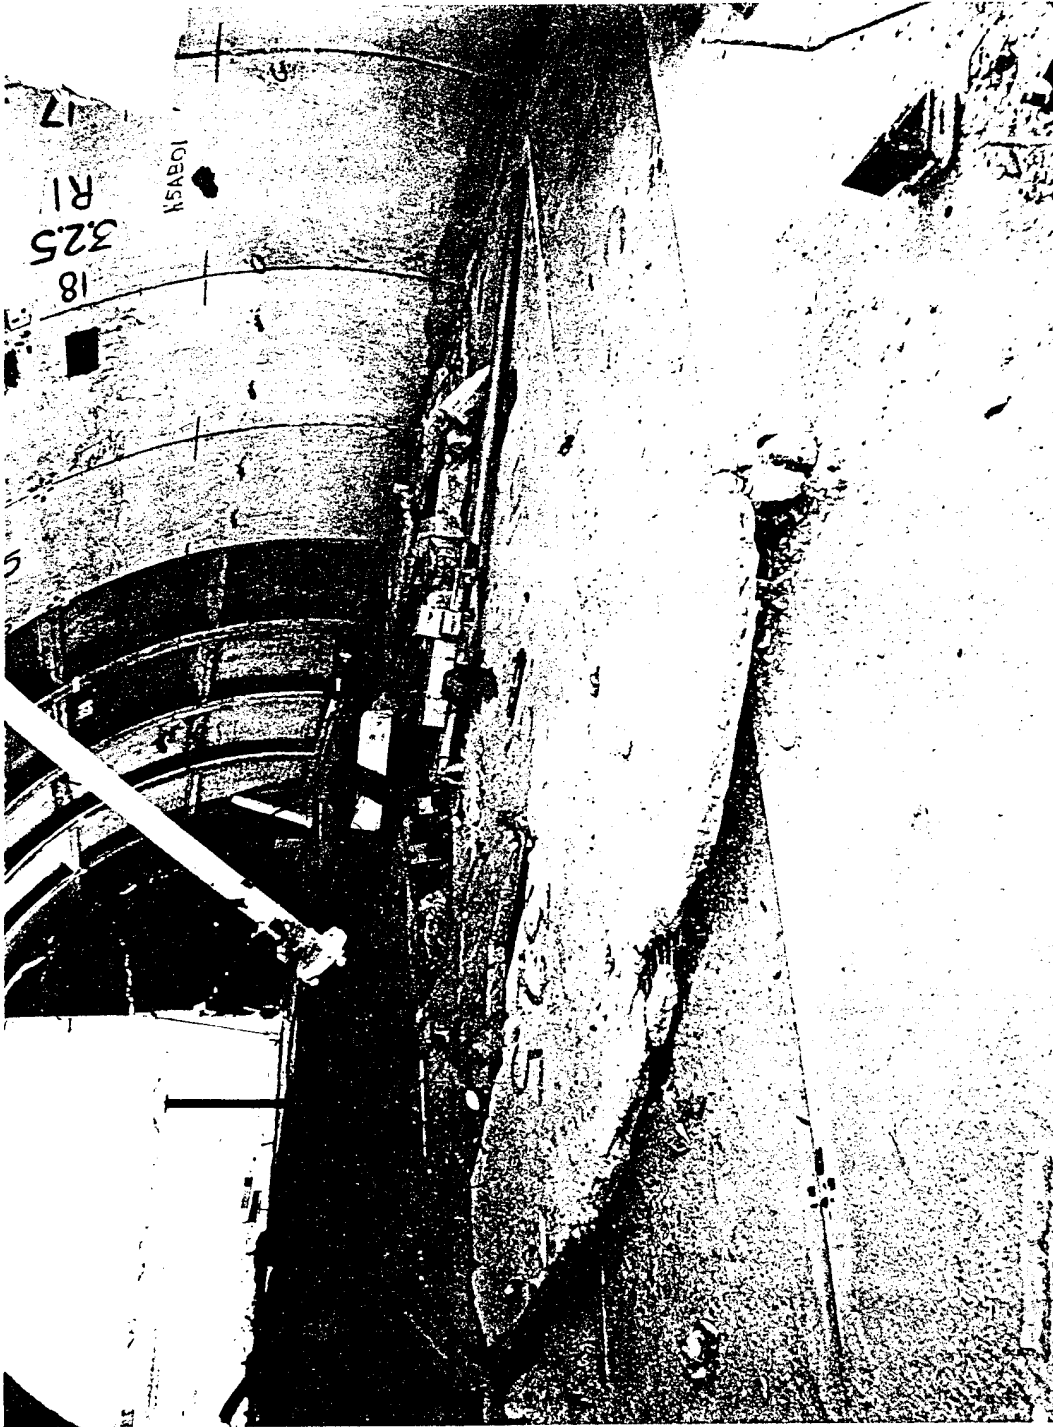
Fig. L.406 Top Half of Rear Panel on Left End Wall Lying inside Structure, 3.2.5

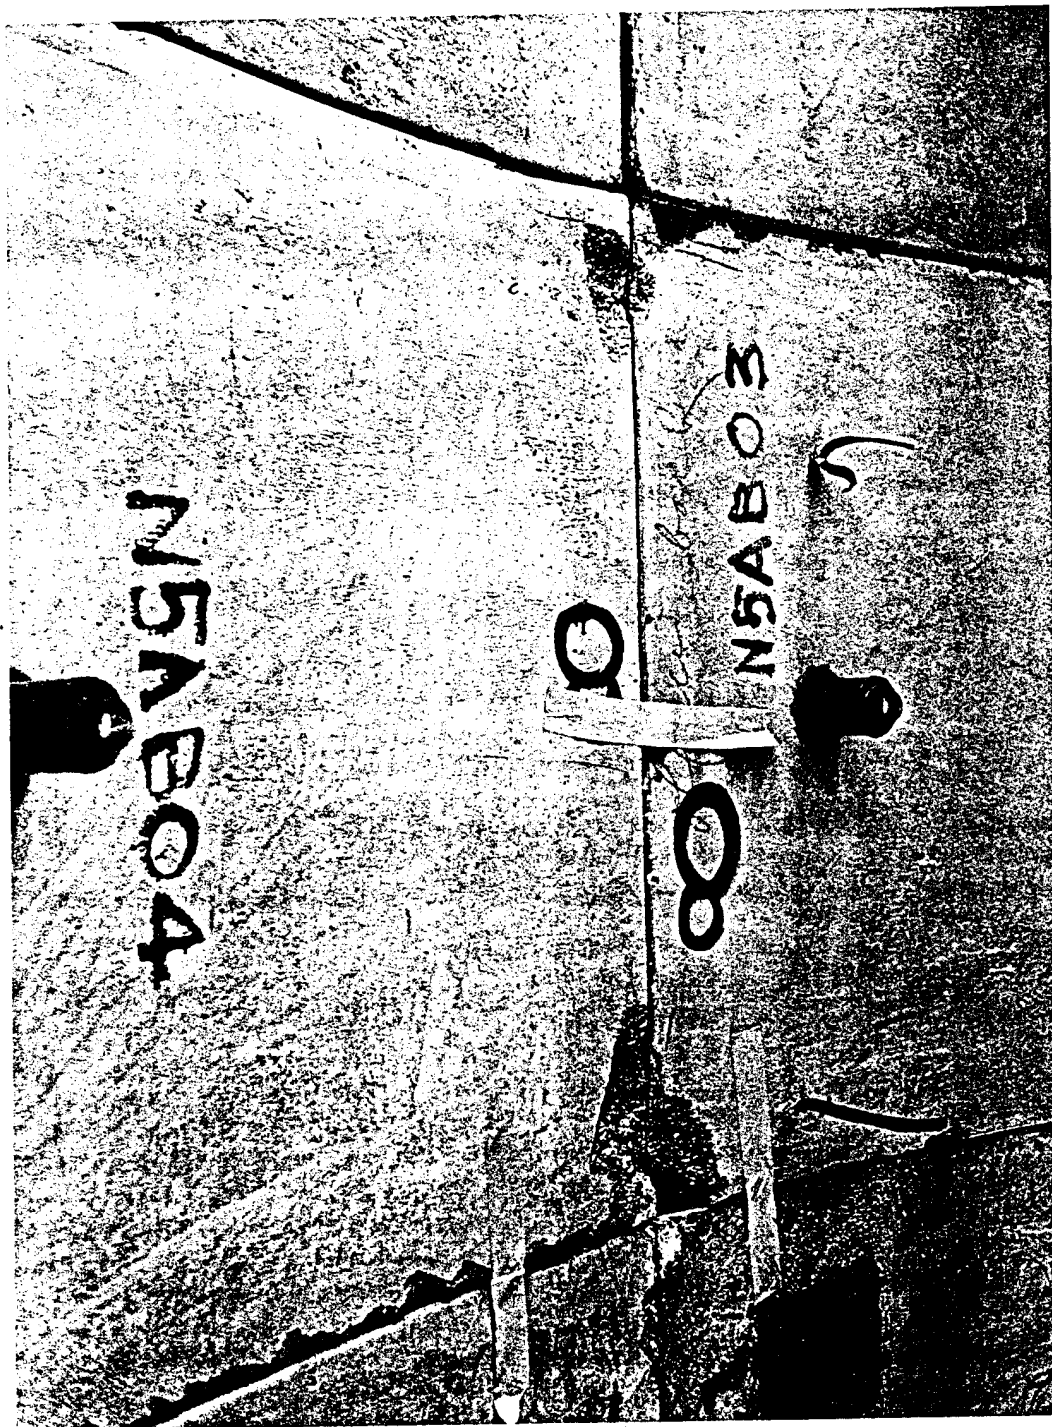
Fig. L.417 Spalling at Peak at Left Center of Arch, Structure 3.2.5

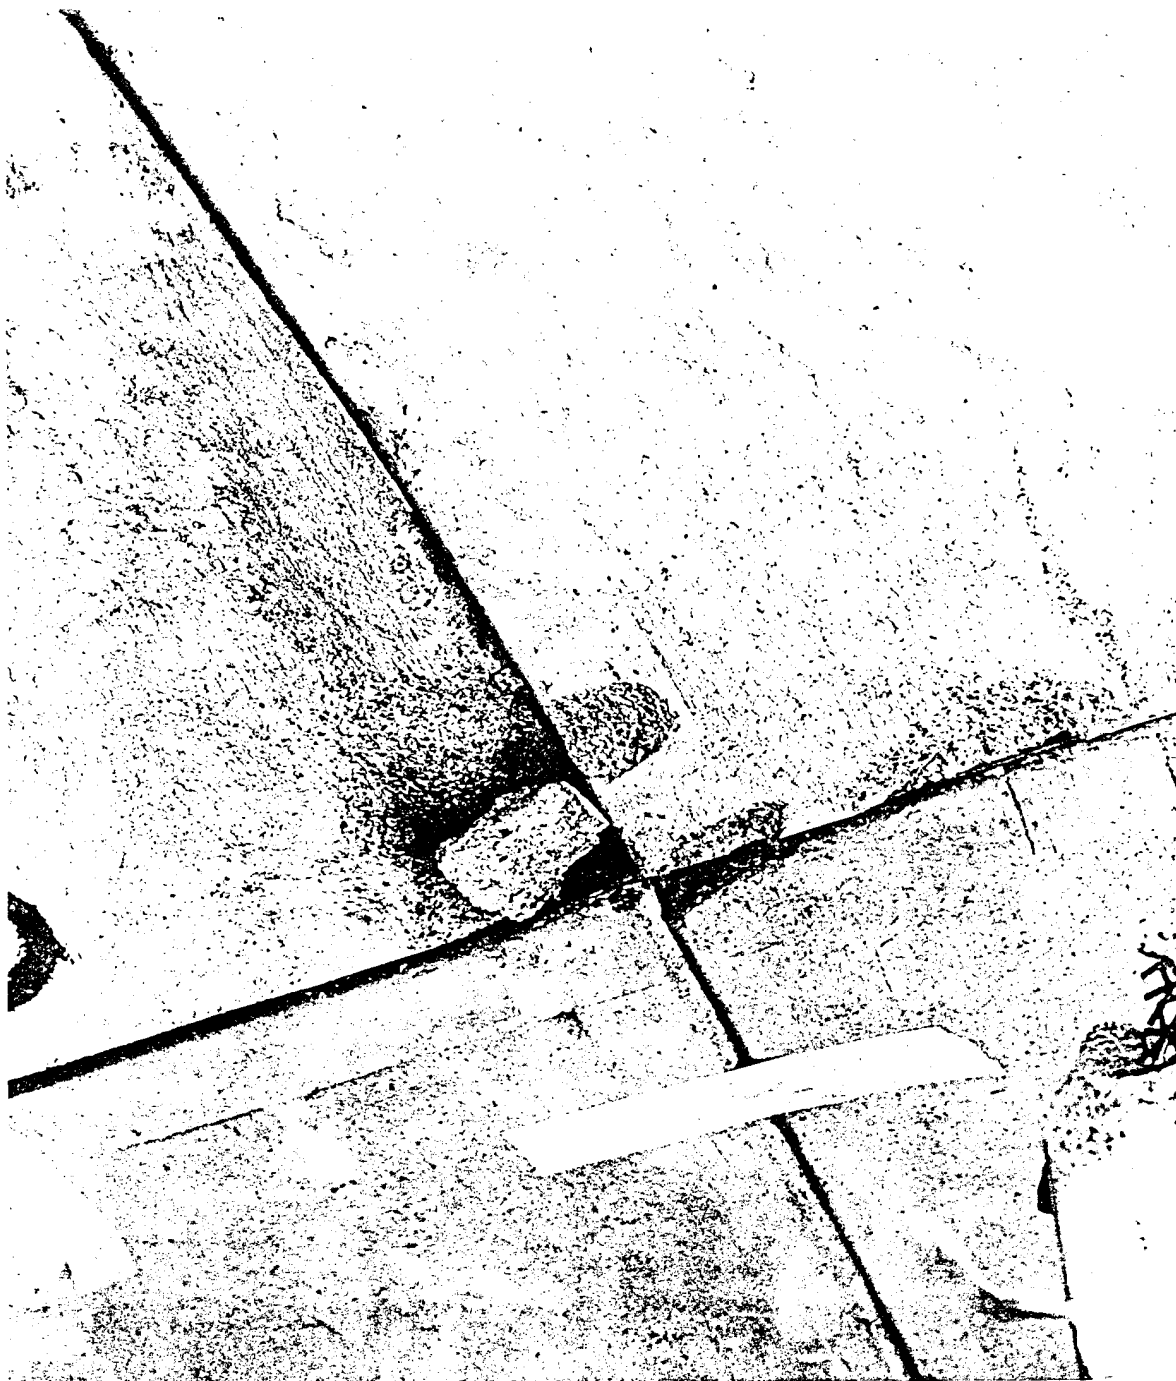
Fig. L. 418 Close-up of Spalling on Interior of Ribs-out Panels (at Peak), Structure 3.2.5

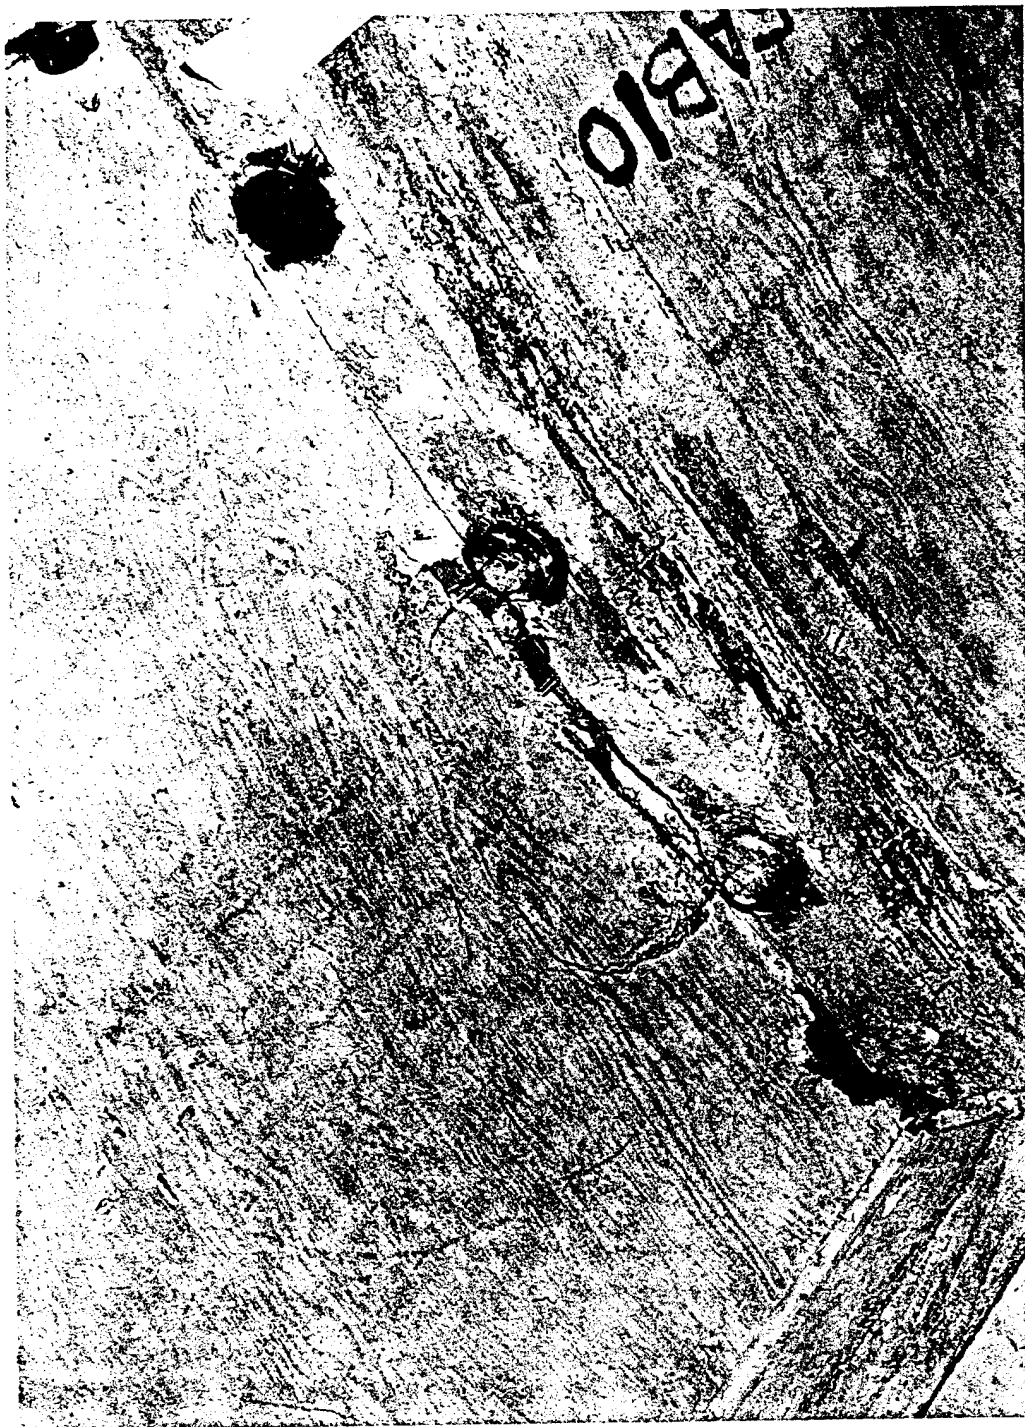
Fig. L. 419 Interior Close-up of Skin on Front Panel Damaged by Flying Fragment, Structure 3. 2. 5

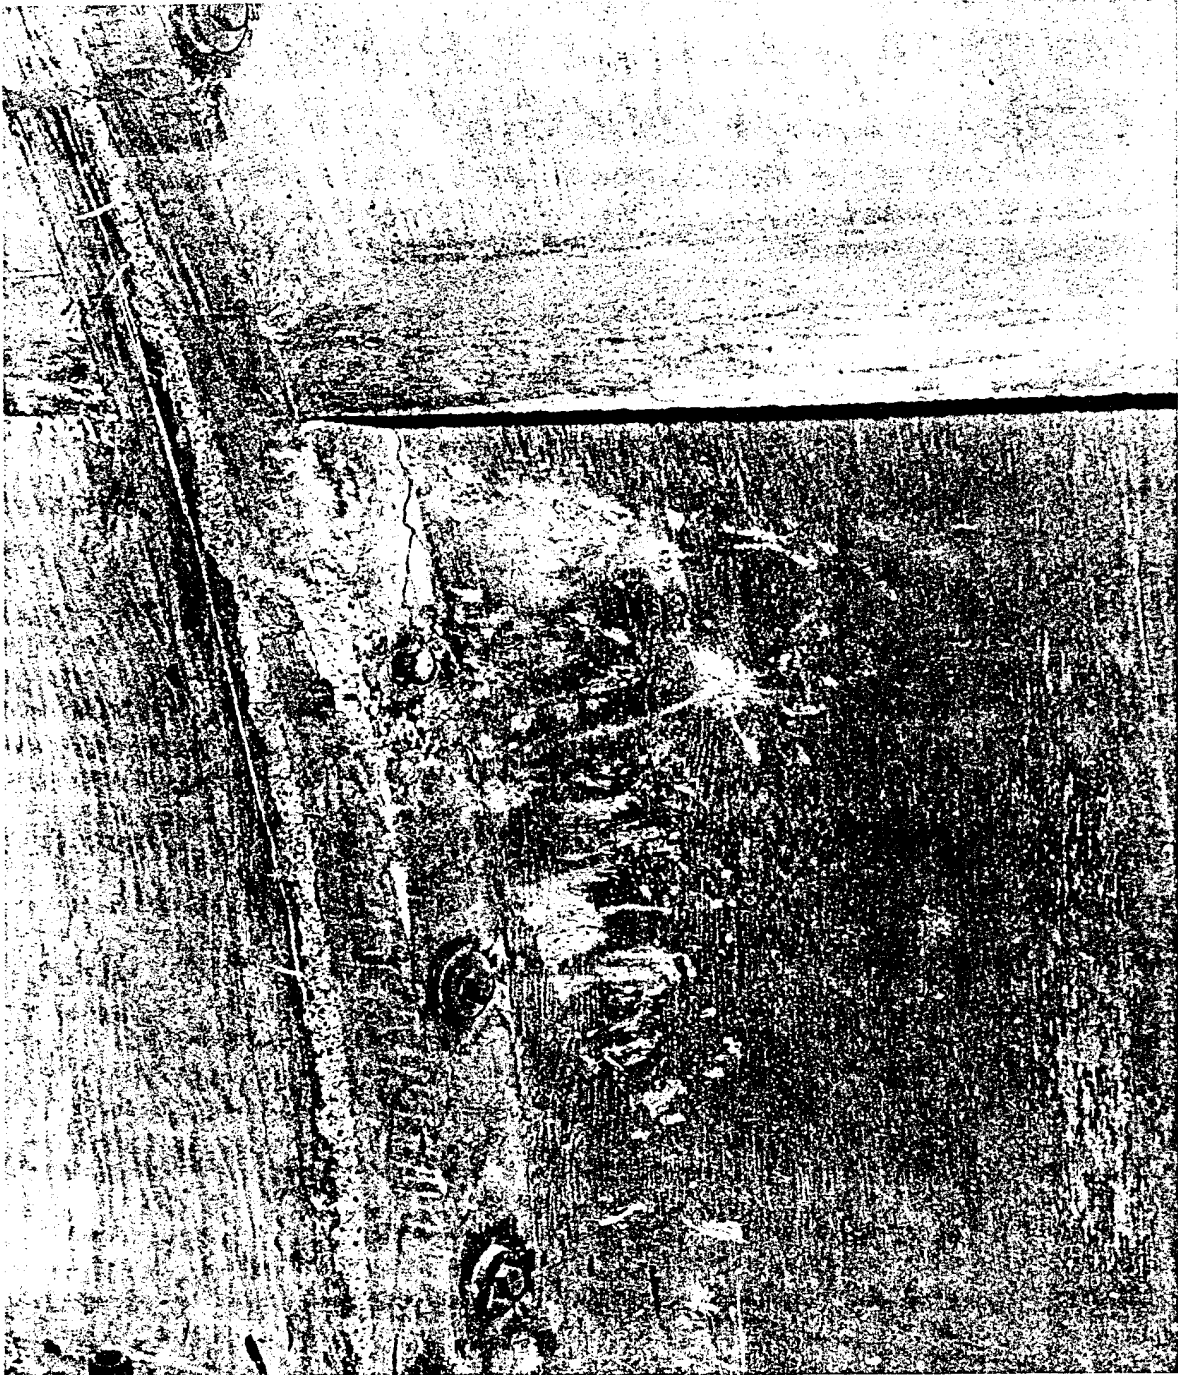
Fig. L.420 Damaged Interior of Rear Panel; Probably Hit by End Walls When They Failed, Structure 3.2.5

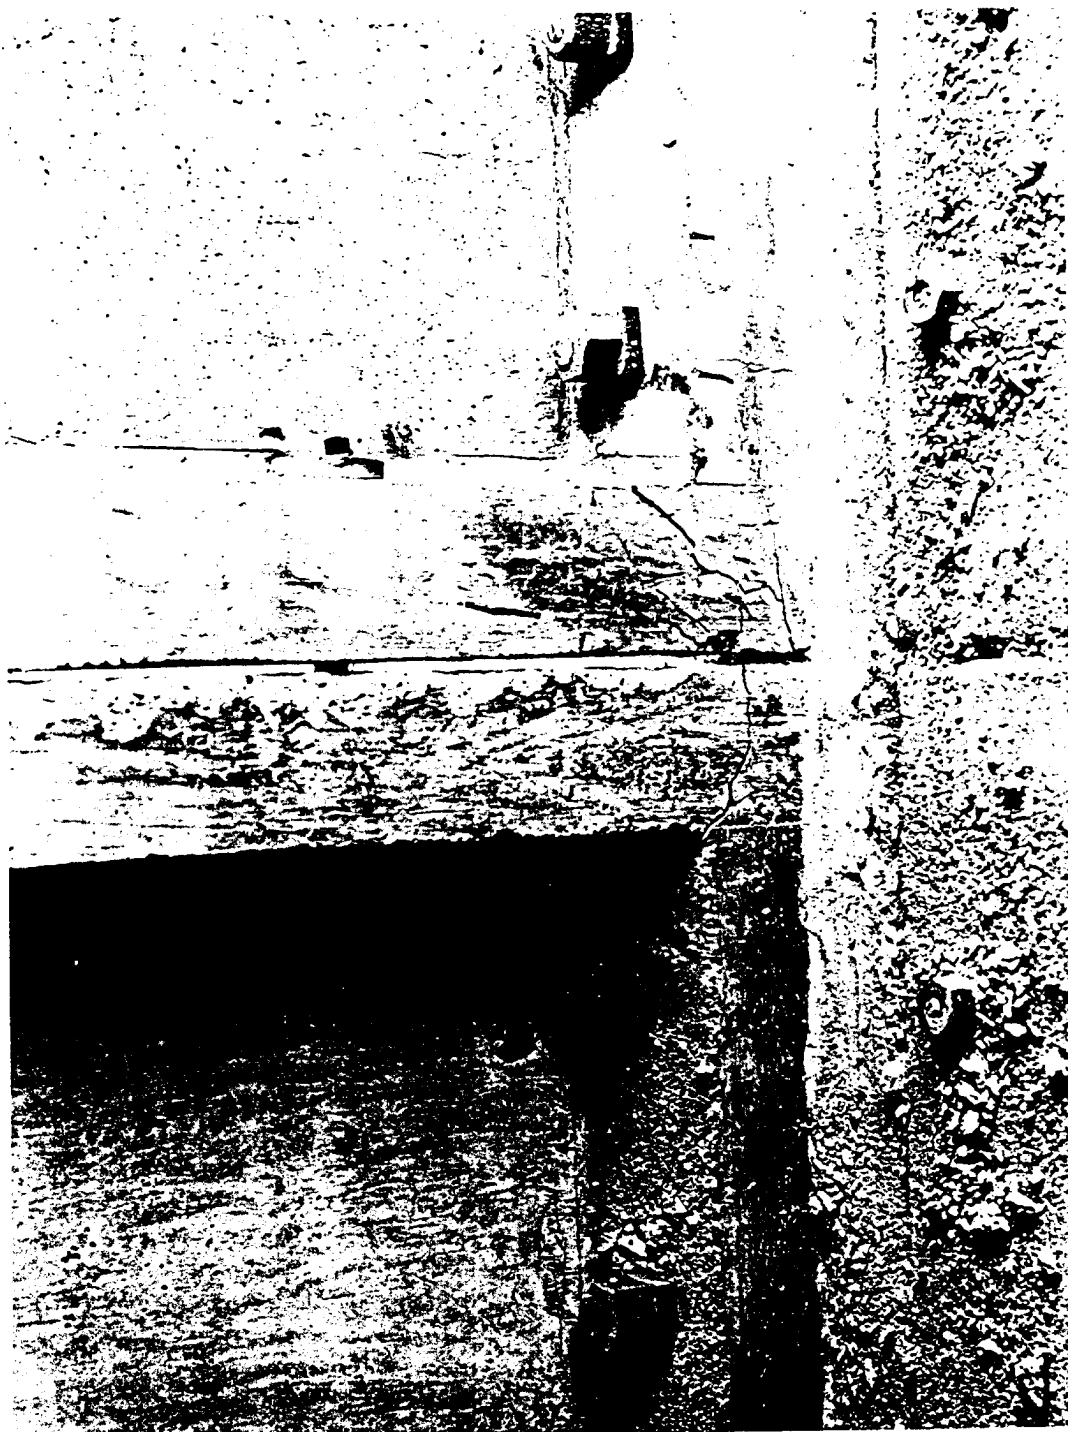
Fig. L.422 Interior Close-up of Base of Rear Panel Cracked in Rib and in Skin, Structure 3.2.5

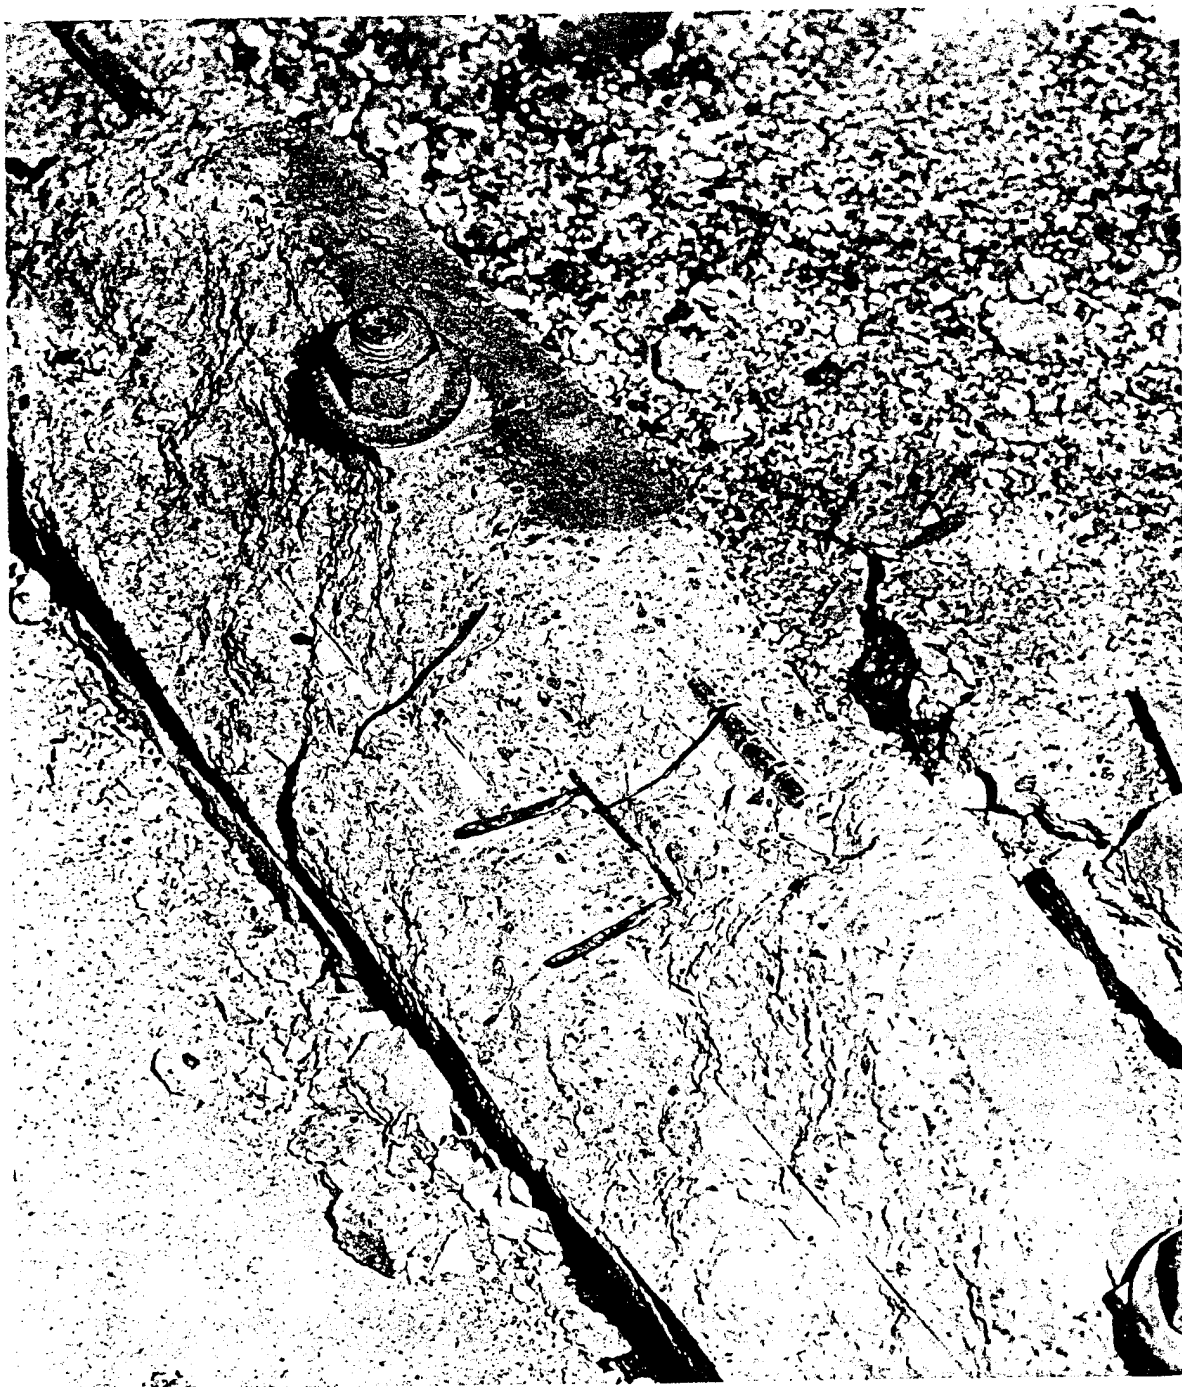
Fig. L. 427 Close-up of Mesh Failure on Bottom Rib of Rear Panel of Right End Wall; Tension Failure, Structure 3.2.5.

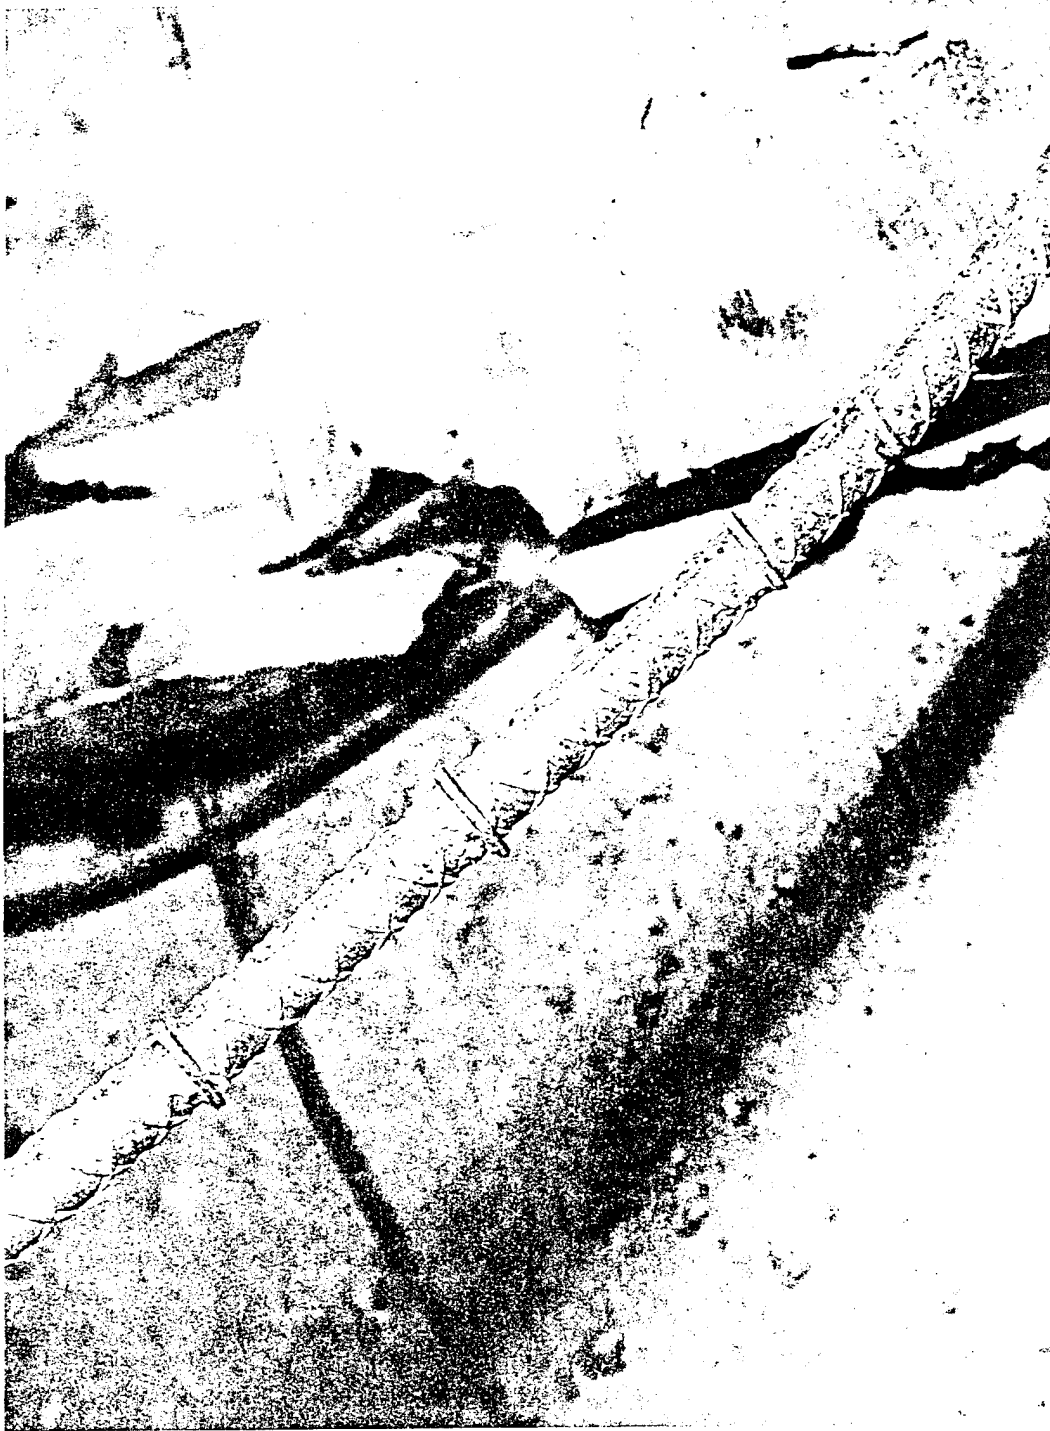
Fig. L.430 Tension Failure of Mesh where Tack Welded to $\frac{3}{8}$ -in. Bar in a Rib, Structure 3.2.5

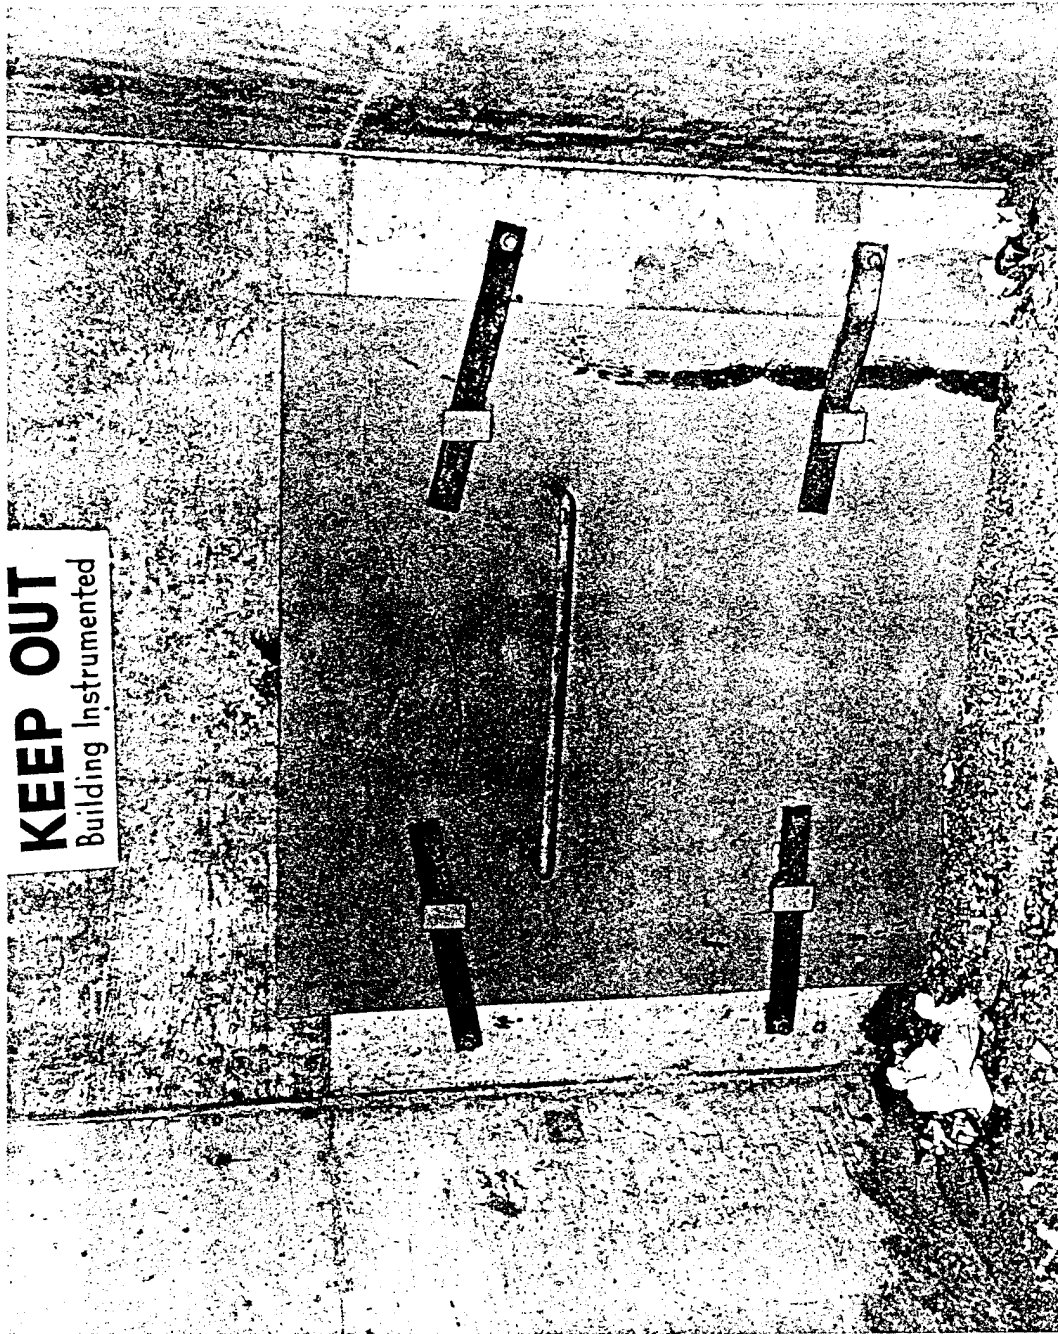
Fig. L.436 Entry Door Showing 2-in. Buckle in Rear Edge, Structure 3.2.6
